CIA/PIR-77034

MILITARY INSTALLATION

HSI-AN, CHINA

34 20N-109 08E

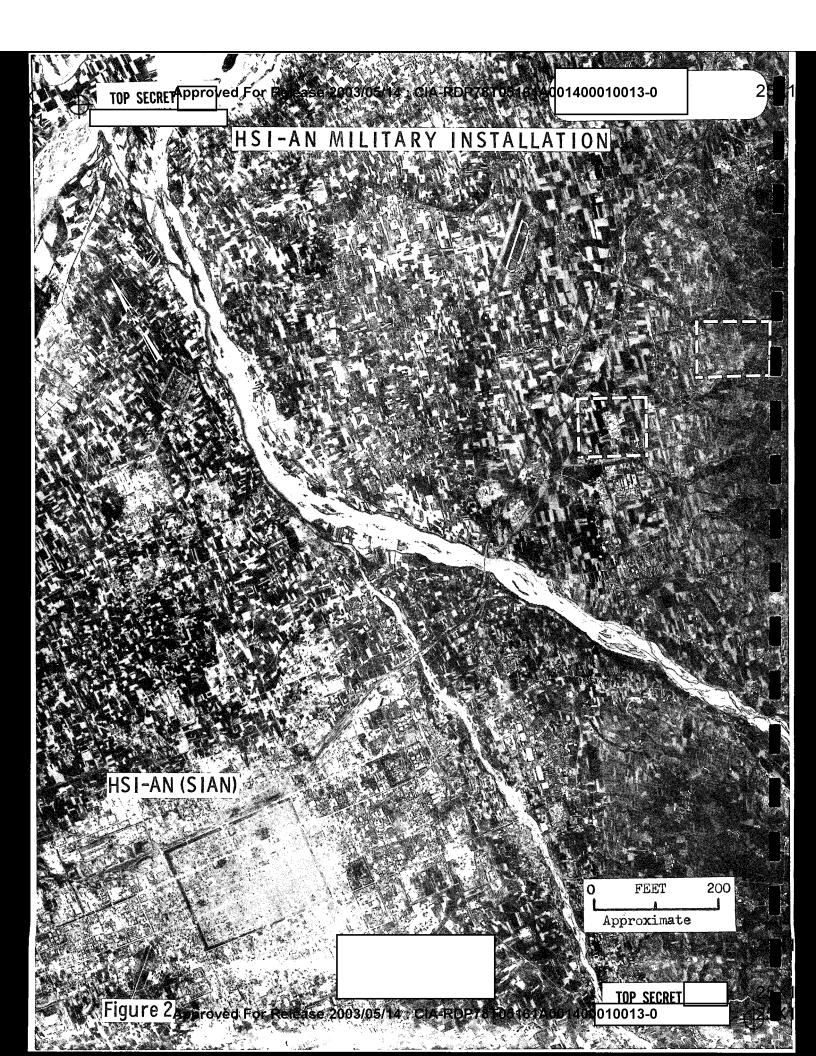
A military installation is located approximately 4.7 nm NE of Hsi-an and is adjacent to the northern side of Hsi-an Munitions Plant #1 (See Fig 3). This report includes a functional analysis of the Hsi-an military installation and the associated tracked vehicle support and driver training area located approximately 2.3 nm east of the installation.

Comparative photography of reveals that approximately 65 percent of the installation was constructed during this interval (See Fig 3).

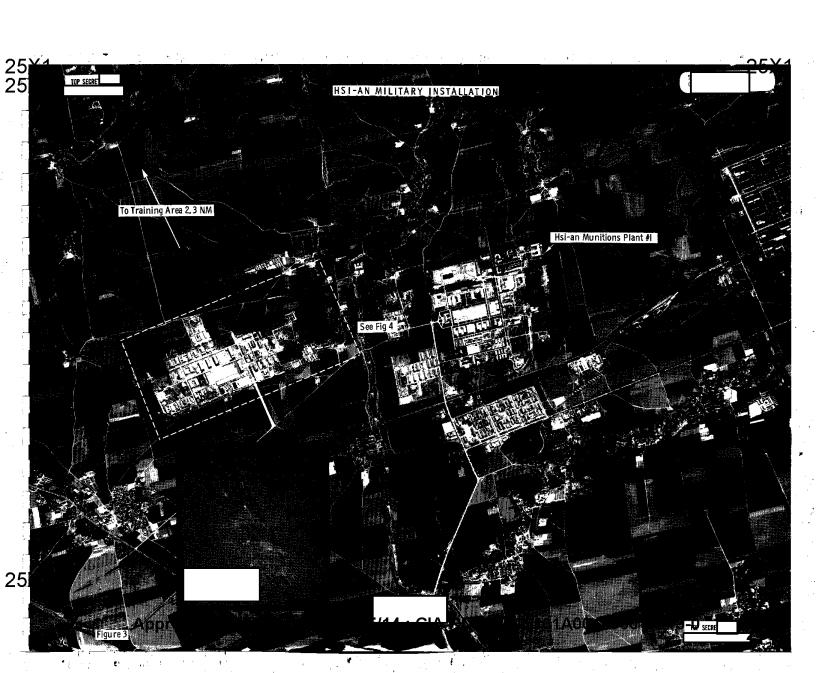
Billeting Area (Figure 4)

This area is not typical of most Chinese Communist Ground Force military installations. The configuration and size of many of the buildings in this area indicates a possible research function may be associated with the area. reveals that 31 new build-Comparative photography of ings were constructed during that time interval. The area contains:

- 12 Probable multistory barracks buildings
 - 4 Probable multistory administration buildings
 - 2 Probable messhalls
 - 2 Heating plants
 - 3 Probable vehicle storage buildings

Vehicles observed in the billeting area are designated by circled numbers.

Item 1

- 14 Probable tanks/assault guns
- 8 Possible tanks/assault guns
- ll unidentified vehicles

Item 2

12 Probable cargo trucks

Unidentified Area Under Construction (Figure 4)

The pattern of the buildings in this area, both those constructed and those under construction, is similar to tank/assault gun facilities_observed in other military installations in China. Comparative photography indicates that construction began

The buildings designated by numbers are:

- 1. Unidentified building under construction 65' x 25' (Approx)
- 2. Unidentified building under construction 145' x 50' (Approx)
- 3. Possible vehicle storage/support building 85' x 50'
- 140' x 30' 4. Possible vehicle storage building
- 5. Possible vehicle storage building 140' x 30'
- 6. Possible vehicle storage building 140' x 30'
- 7. Possible vehicle storage building 140' x 30'

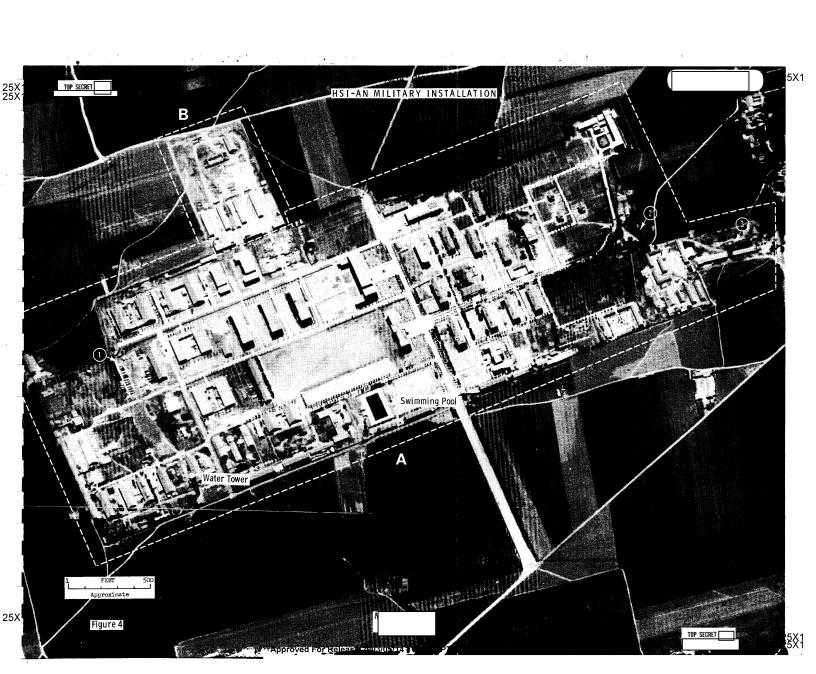
- l Possible Gymnasium/Auditorium building
- 45 Support buildings

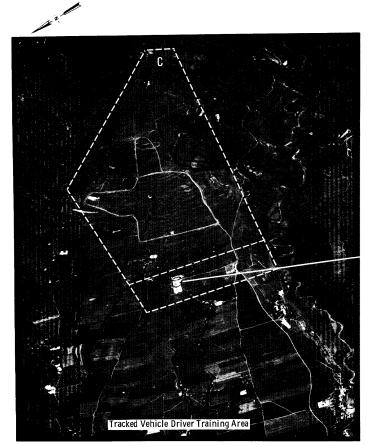
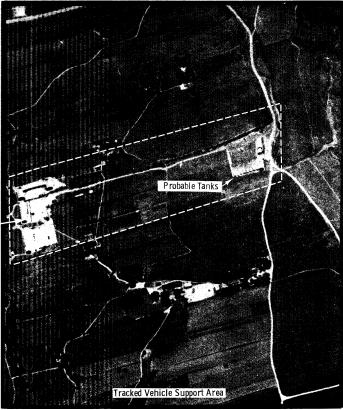
Figure 5

HSI-AN MILITARY INSTALLATION TRACKED VEHICLE SUPPORT AND DRIVER TRAINING AREA

The tracked vehicle support area contains 5 support buildings. There are 11 probable tanks located in this area -- 10 appear to be canvas covered. Obliquity precludes mensuration data in this area.
